BAGHDAD INTERNATIONAL AIRPORT  
POWER SYSTEM ENHANCEMENT  
BAGHDAD, IRAQ

SUSTAINMENT ASSESSMENT

**SIGIR PA-07-097**  
**APRIL 26, 2007**

## **Baghdad International Airport Power System Enhancement Baghdad, Iraq**

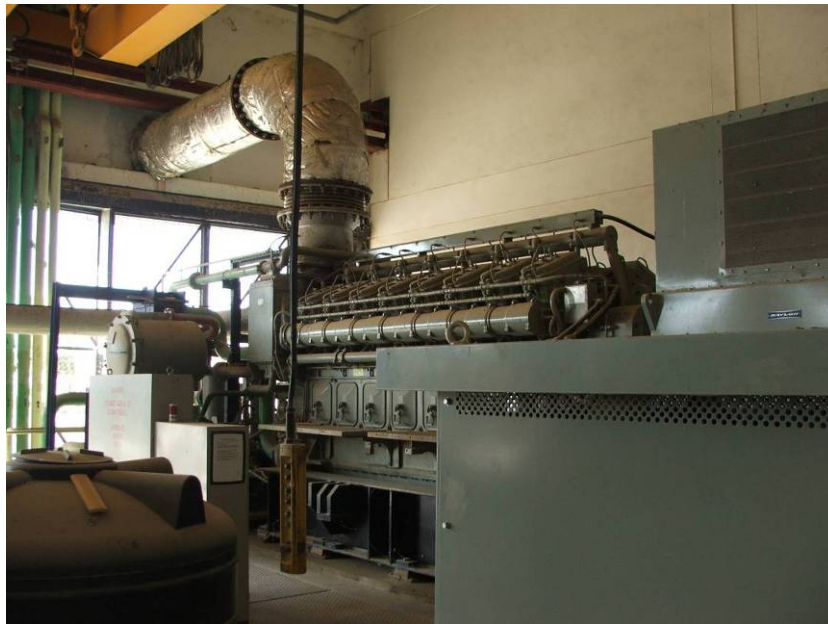
During the 3 March 2007 visit, the GE generator sets were not operational. The USAID and GRD representatives were unaware that the GE generator sets were not operational, and the BIAP power plant manager stated that the GE generator sets have been non-operational for approximately 17 months (September 2005 through March 2007). The three GE generator sets are necessary for the electrical power requirement at BIAP.

**Site Photo 11. General Electric generator**

1. Perform the necessary critical repairs to the Cummins, Caterpillar, and General Electric generator sets.
2. Implement an effective Operations and Maintenance plan with a trained staff and spare parts for the Baghdad International Airport.

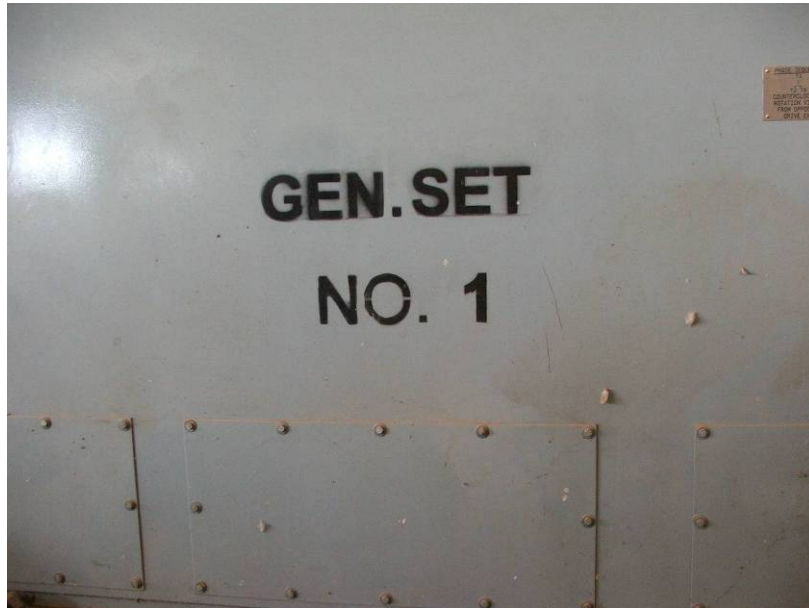
Site Photo 12. General Electric generator set 1

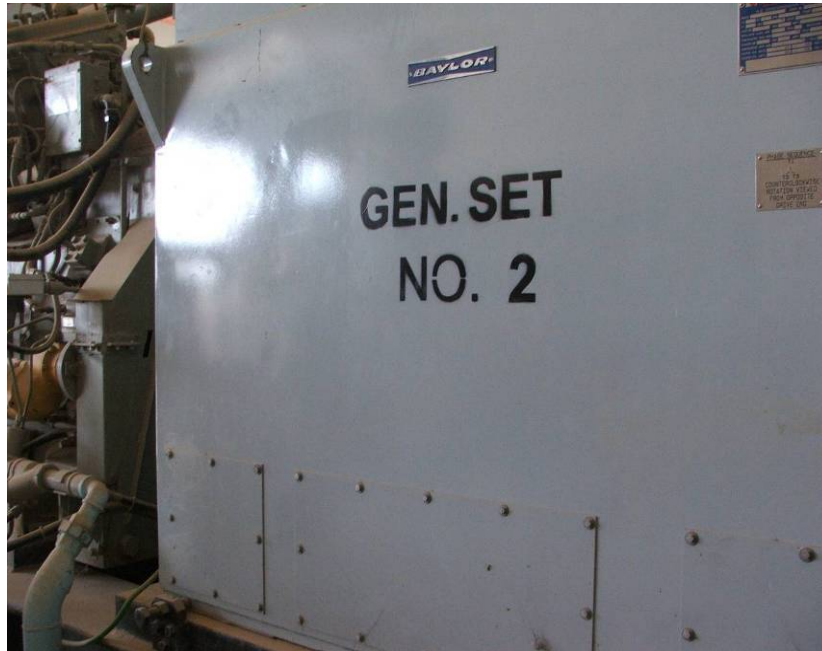
Site Photo 14. GE generator set 2

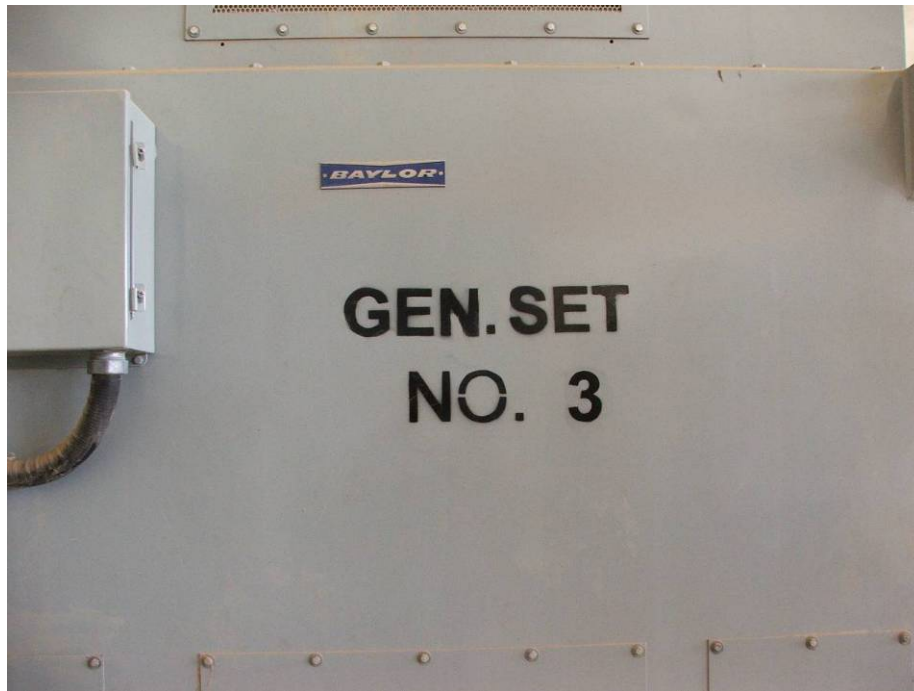
Site Photo 16. GE generator set 3

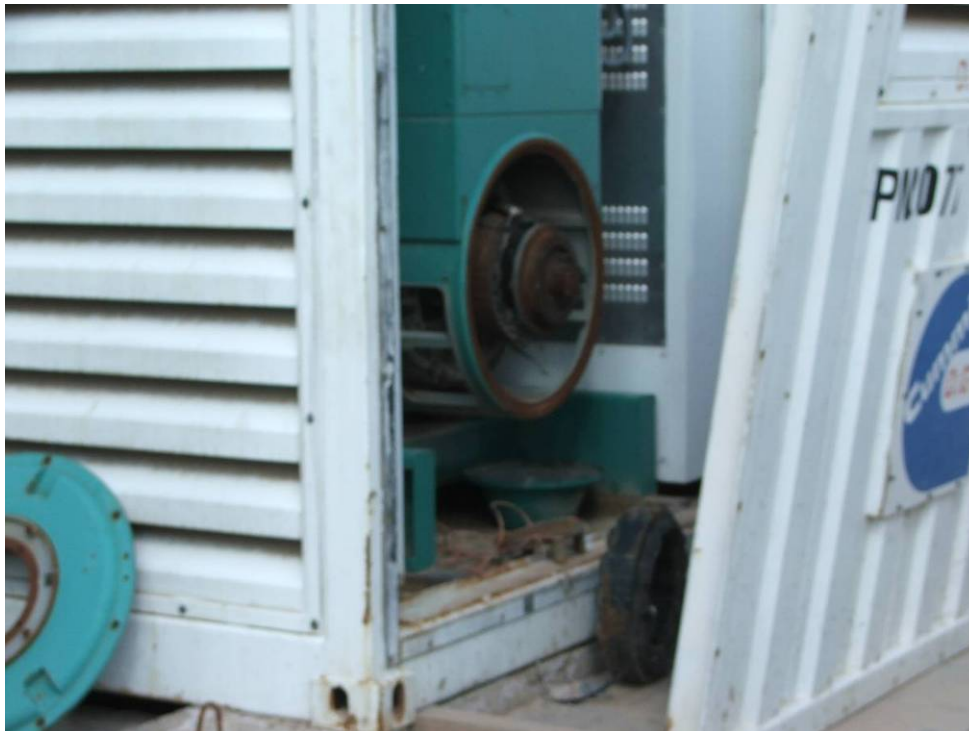
only) identify the Cummins generator set identification (ID) numbers. The Cummins generator area has its own fuel tanks, shown in Site Photo 32. Site Photo 33 shows one of the five Cummins generator sets that was not operational. The five Cummins generator sets are required to meet the electrical power requirement at the BIAP.

**Site Photo 33. Cummins generator set 2 disassembled & unprotected from weather**

Significant maintenance and repairs on the Cummins and Caterpillar generator sets are now required in order to achieve and sustain needed power production capability for operation of the BIAP power plant. Full load operation at the BIAP power plant complex has not been realized as of this report. The sustainability of the power plant facility will not be achieved unless all of the equipment is properly operated, the operators trained, and the generator sets maintained using an O&M or PM plan.

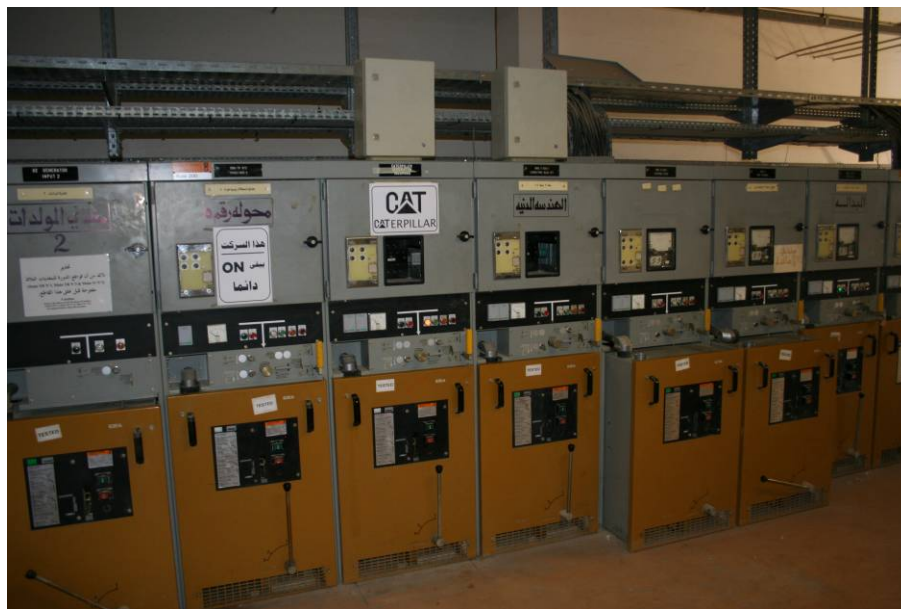
Cummins and CAT generator sets, respectively. The systems appeared to be working at the time of the SIGIR visit.

**Site Photo 49. System for Caterpillar generator sets**
